Project Examples

Oil Tank Locating – Vancouver, BC

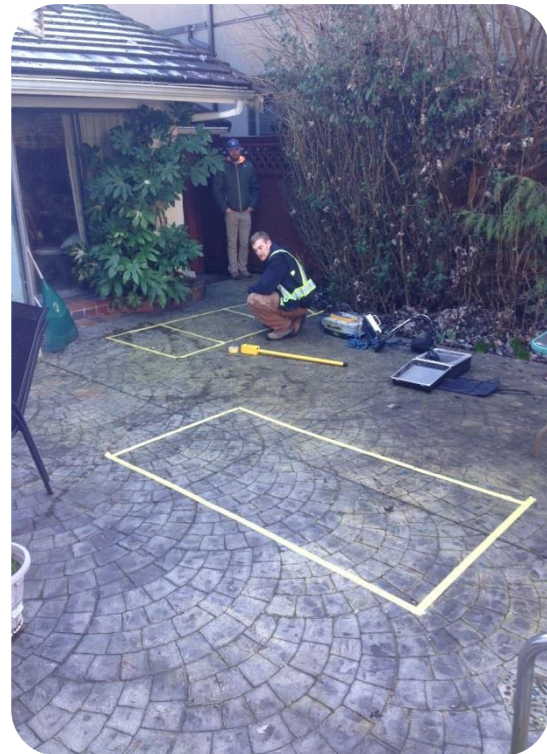
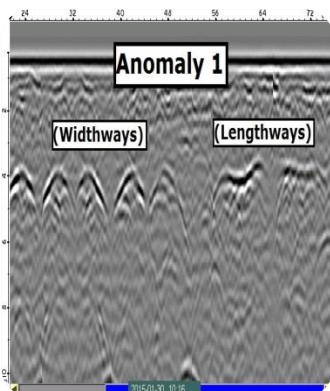
GeoScan performed a subsurface survey of the neighbouring property using Ground Penetrating Radar and a ferromagnetic locator which revealed not one but two large anomalies on the property close to the contaminated property border. One anomaly had a broken reflection in the lengthways direction, suggesting perhaps the metal anomaly was not complete, or partially broken.

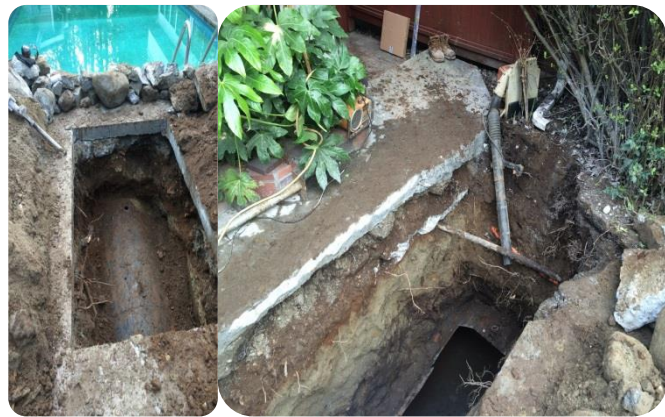
The anomalies were day lighted and revealed two underground oil storage tanks, one in which had been partially cut open, right near the fence line, most likely the cause of the contamination.
