Project Examples

Concrete Scanning – Port Mann Bridge

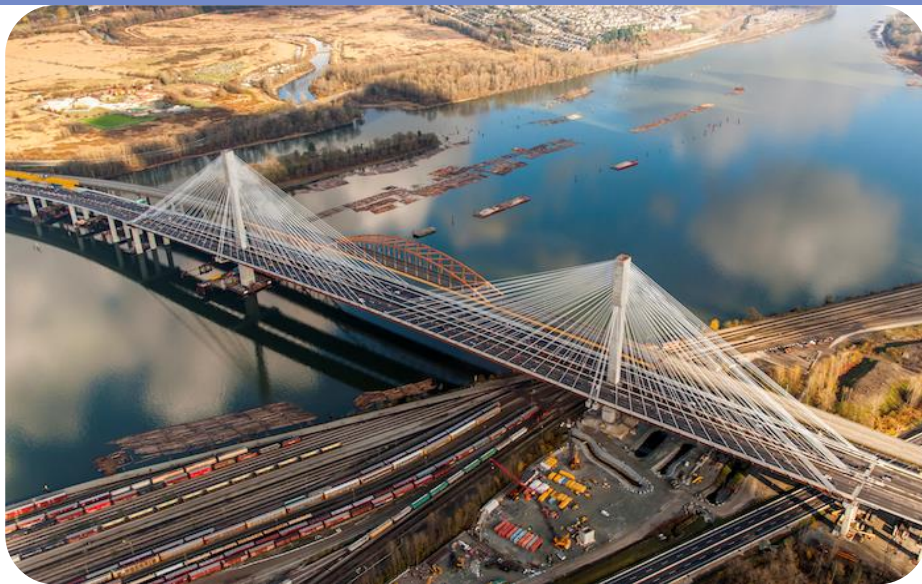
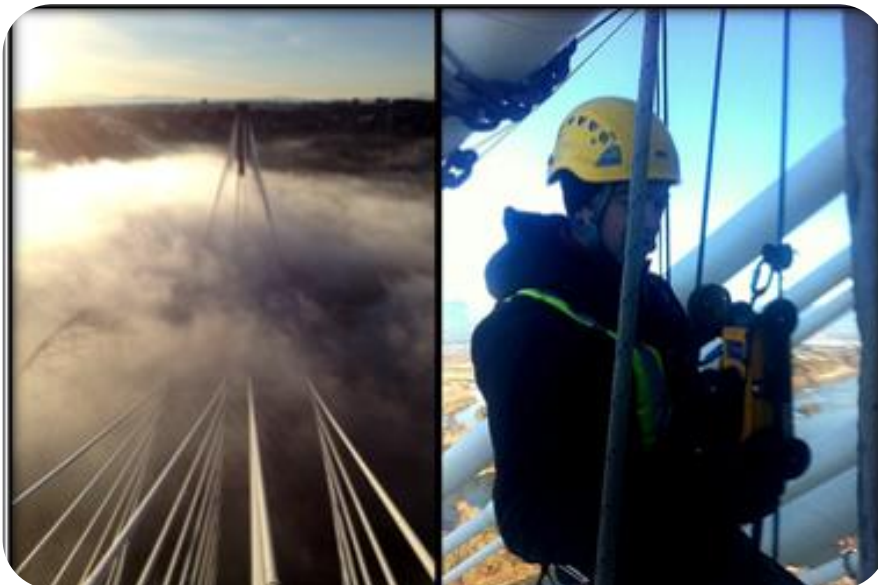
GeoScan were employed to scan the top of both 163 meter high towers, which support the cables, for the installation of new de-icing mechanisms. The location of the rebar was accurately marked out on the slab so that it could be avoided during the drilling process.
