Project Examples

Concrete Scanning & Coring – North Vancouver, BC

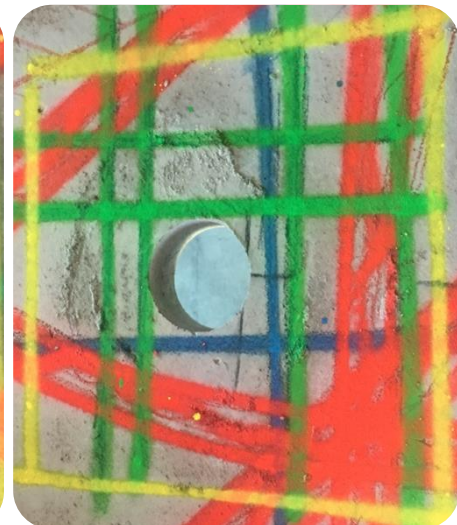
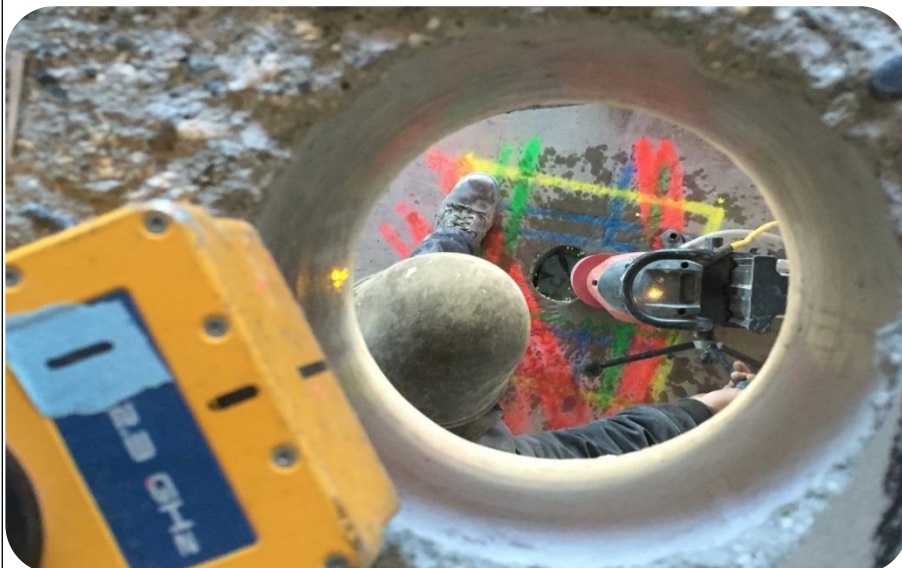
Each location was scanned by a fully trained GeoScan technician using High frequency Ground Penetrating Radar (GPR).

In addition to structural steel (blue/green) the technician was able to identify multiple, embedded electrical conduits (red) within close proximity of the holes. These holes were either cleared or relocated to avoid hazardous electrical conduits. Each location was then cored safely.
