Interpretation of Results

SITE ADDRESS	TITLE INTERPRETIVE RESULTS 0.6 AND 1.0 METERS
DRAWN BY: J.DURRANT	PROJECT NO. J181210-04
DECEMBER 2018	SHEET NO. 7 OF 10

INTERPRETED RESULTS – UTILITIES, DRAINAGE CONDUITS AND SHALLOW GEOLOGY

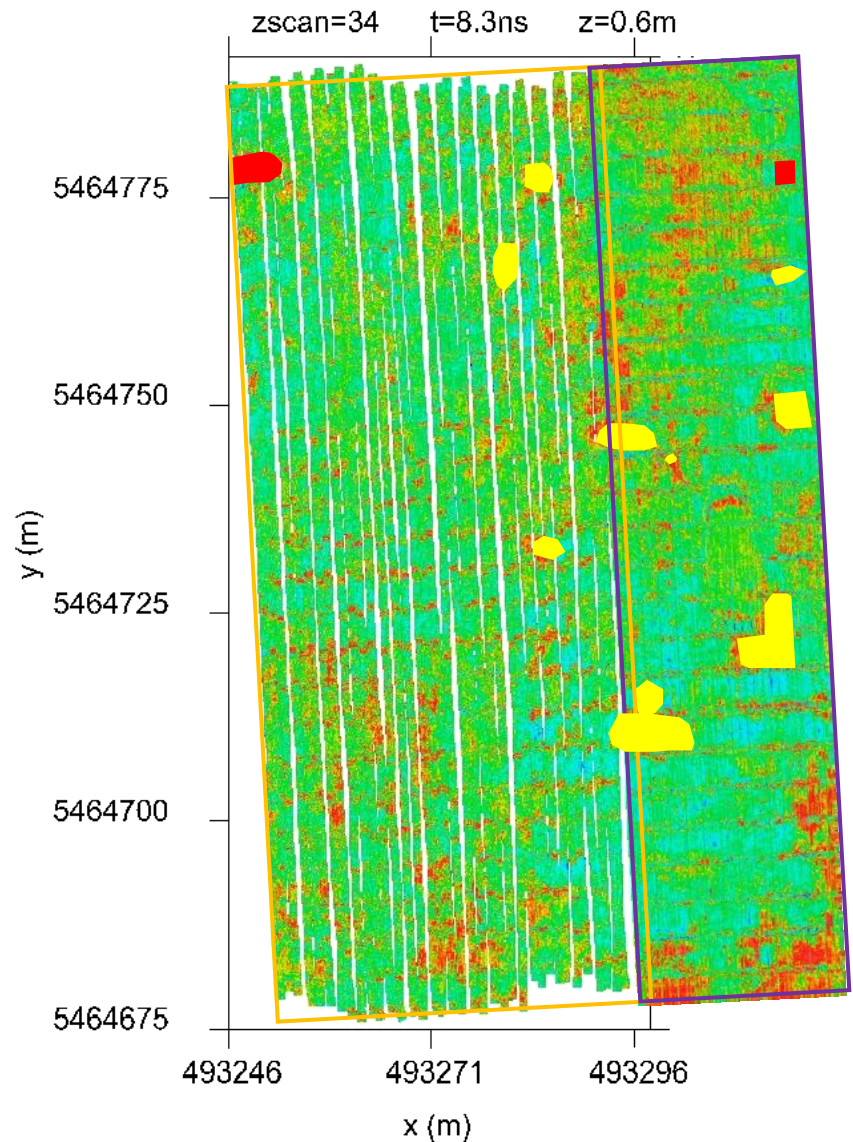
Processed Results

**AMPLITUDE**

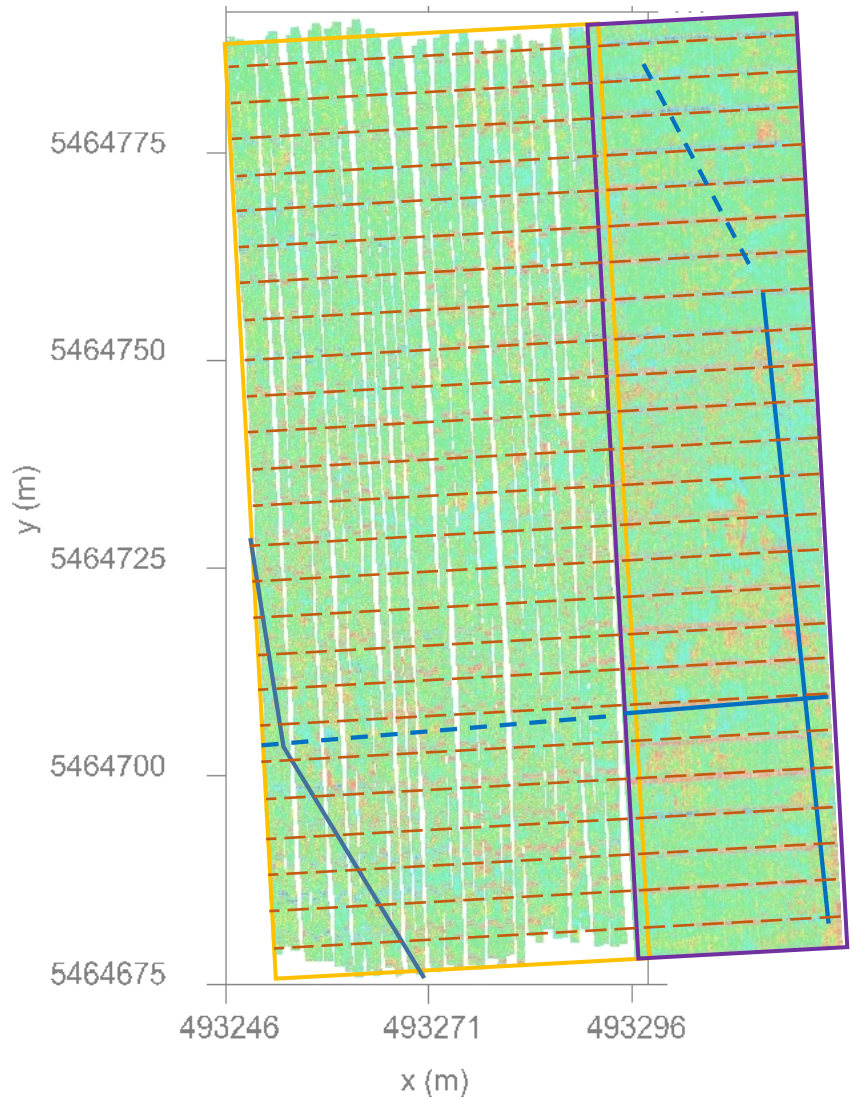
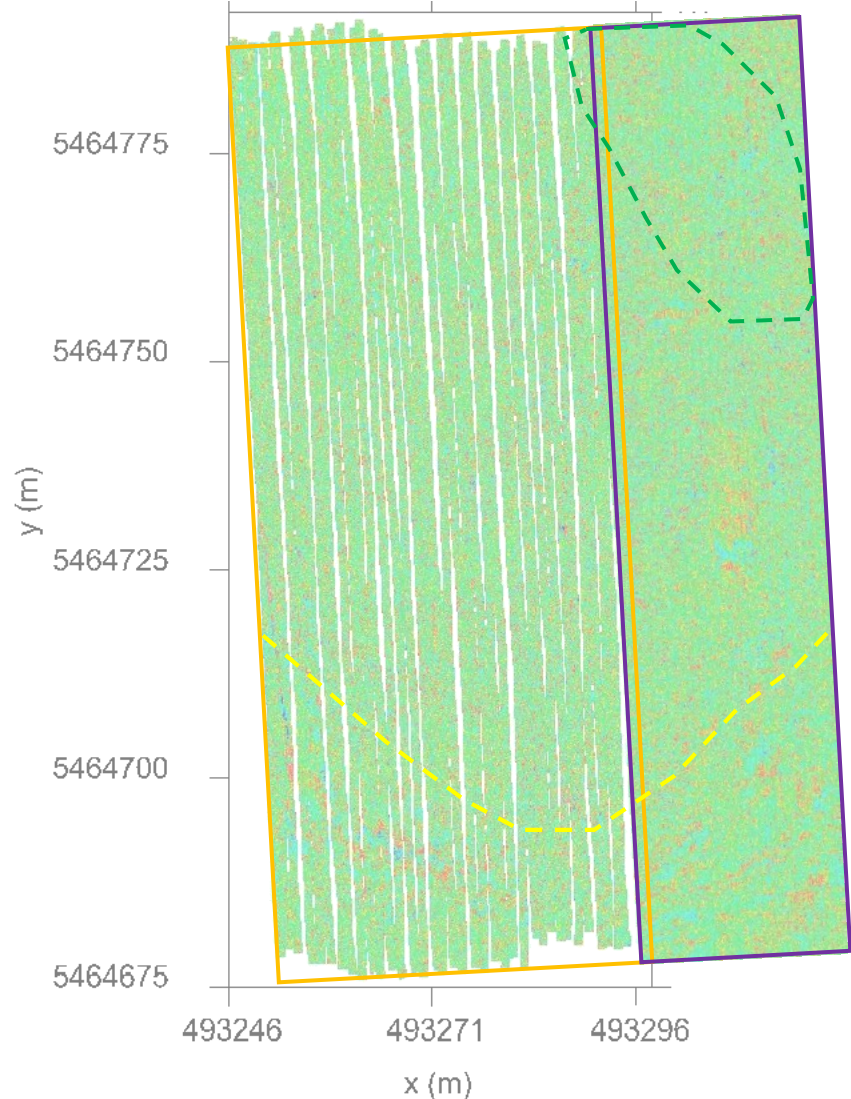
CLIENT	
SITE ADDRESS	TITLE INTERPRETIVE RESULTS 0.6 AND 1.0 METERS
DRAWN BY: J.DURRANT	PROJECT NO. J181210-04
DECEMBER 2018	SHEET NO. 8 OF 10

PLEASE NOTE: DRAINAGE CONDUITS OBSERVED BETWEEN 0.5 AND 0.8 METERS DEPTH. UTILITIES AND SUSPECTED UTILITIES OBSERVED BETWEEN 1.2 AND 2.4 METERS DEPTH. SHALLOW DISTURBANCE TO THE NE OF SITE AND DIPPING BACKFILL BOUNDARY AT ~1.0 METERS.

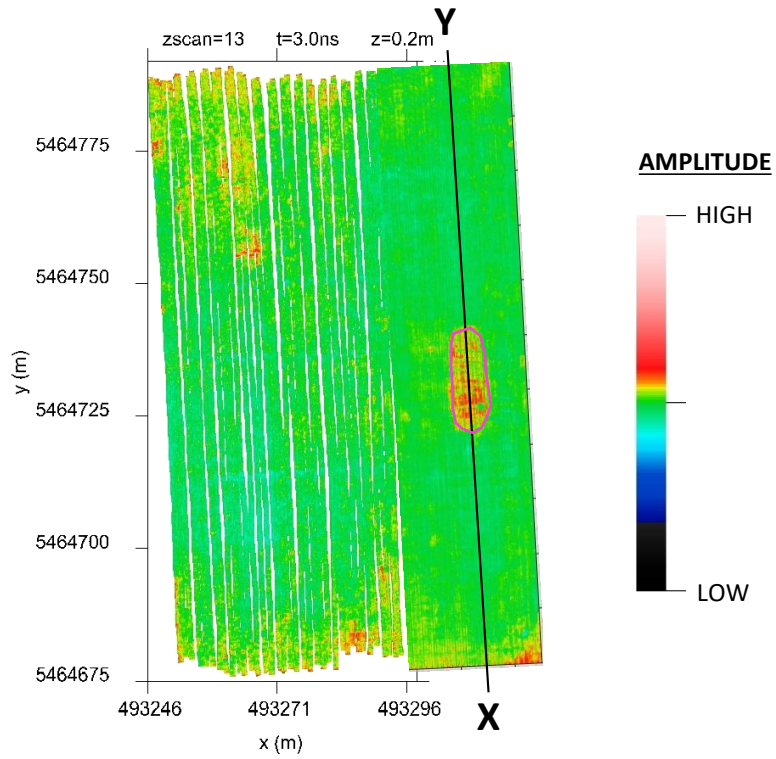
LOCATION OF X – Y PROFILE SHOWING SHALLOW SUBSURFACE MORPHOLOGY

NOTE: SUBSURFACE DISTURBANCE DELINEATED BY THE PINK BOUNDARY SUSPECTED TO BE DUE TO MORE WATER SATURATED GROUND CONDITIONS WITHIN THIS AREA.
