Project Examples

Asphalt Thickness Mapping – Burnaby, BC

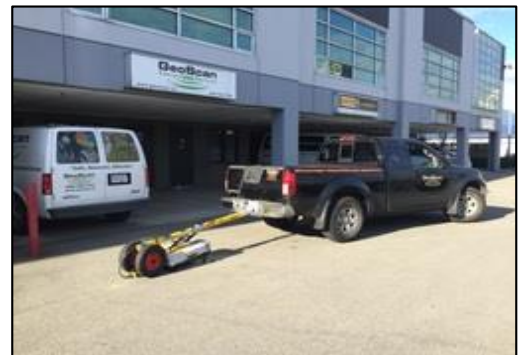
GPR Data Showing Asphalt Thickness

The survey revealed the extent of the asphalt thickness and highlighted the areas which actually needed repairing therefore saving time and money resurfacing unnecessary portions of the road.

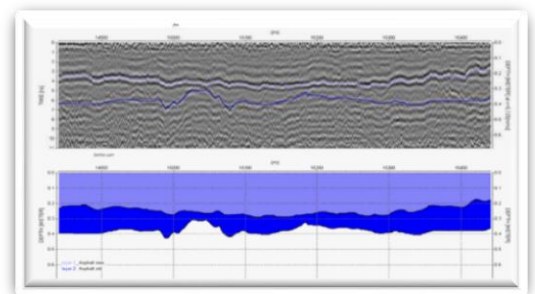
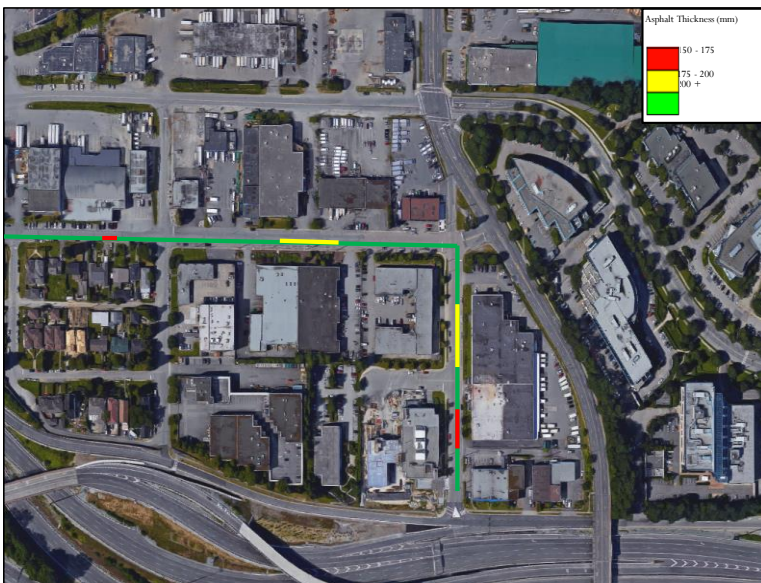
GeoScan utilizes the latest GPR equipment which can operate at highway speed and requires no traffic control.
