Conductivity Results Map

<p>SITE ADDRESS:</p> <p>VANCOUVER ISLAND, BC</p>	<p>CREATED BY:</p>
			<p>JOB ID:</p>	<p>SURVEYED BY:</p>

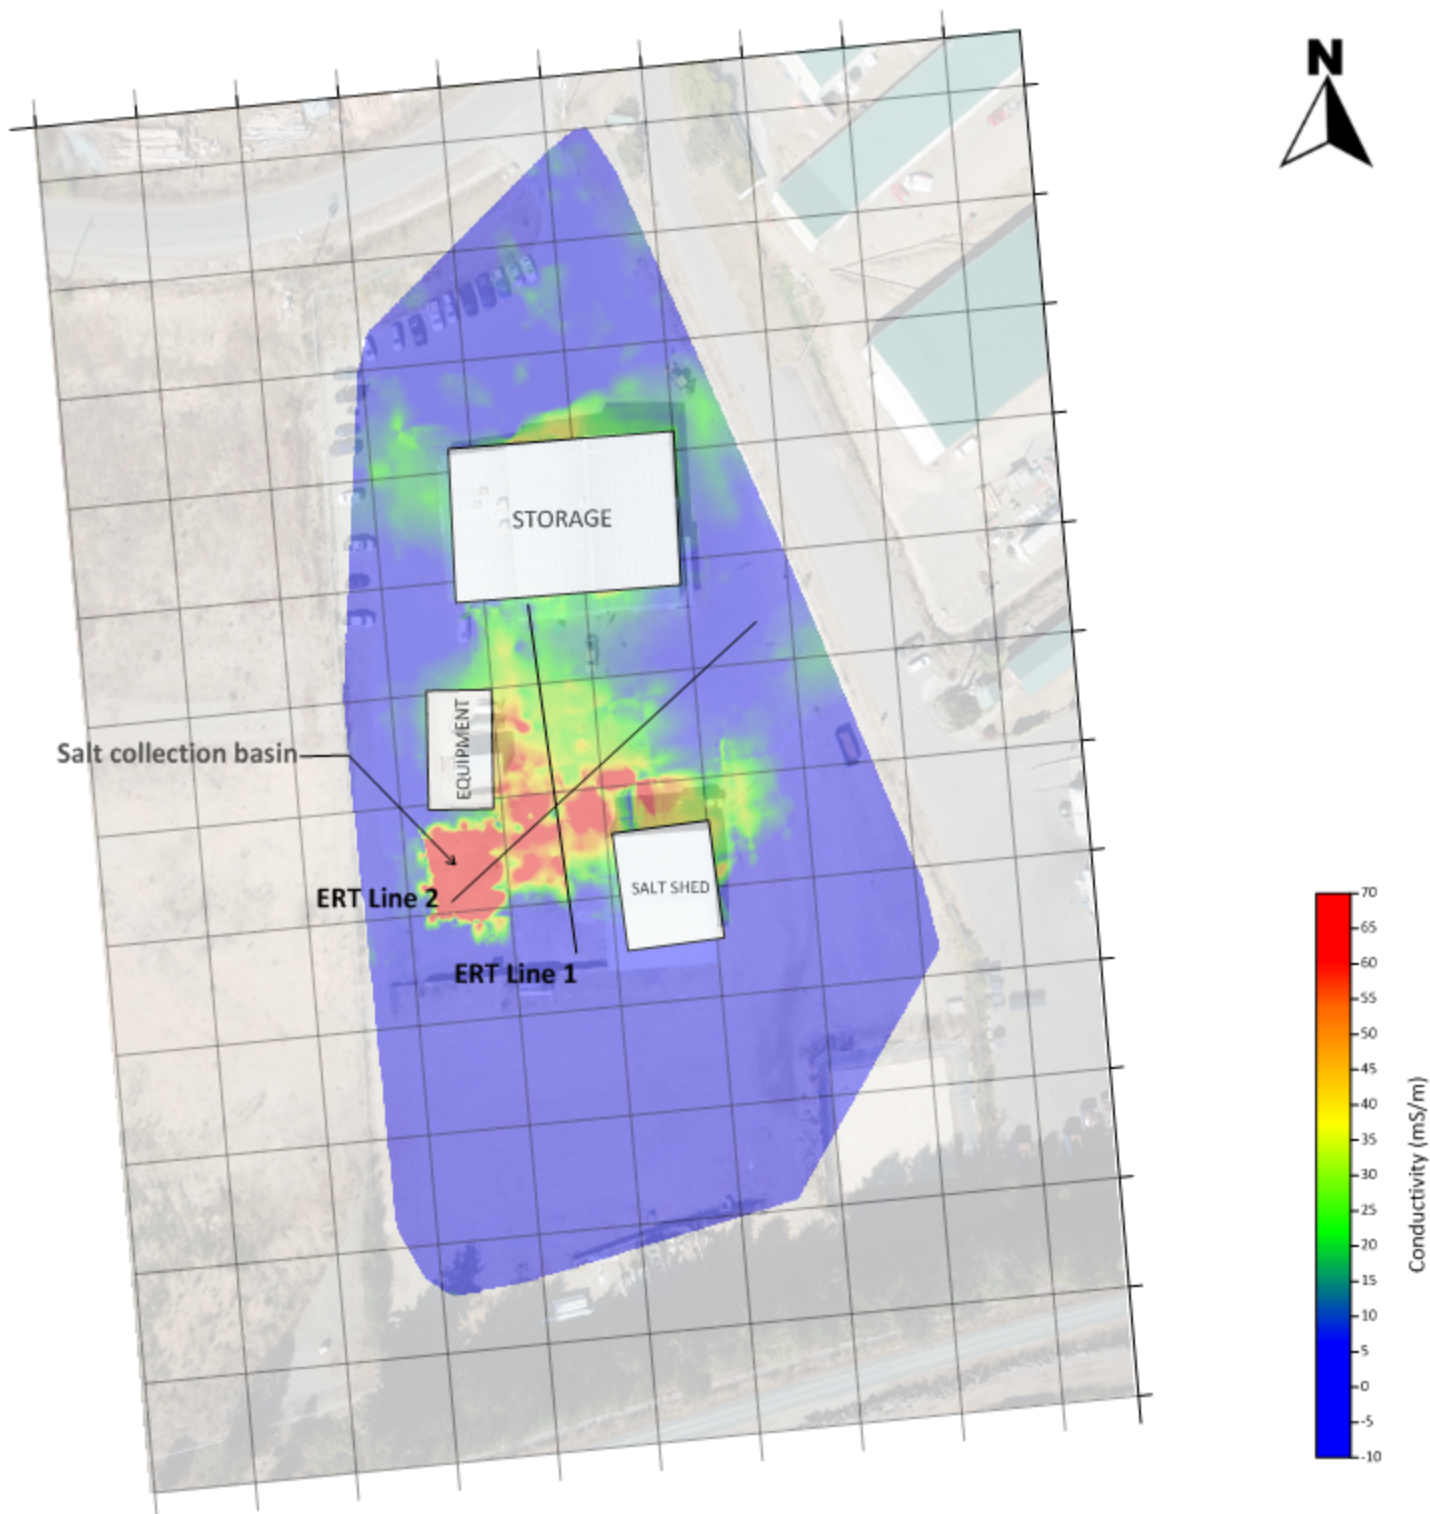
<p>CLIENT:</p>	<p>FIELD NOTES:</p> <ol style="list-style-type: none"> 1. CONDUCTIVITY SURVEY COMPLETED BY GEOSCAN SUBSURFACE SURVEYS IN SEPTEMBER 2018. CHANGES TO THE SITE THAT OCCURRED FOLLOWING OUR INVESTIGATION WILL NOT BE SHOWN. 2. THE SURVEY WAS PERFORMED USING ELECTROMAGNETIC (EM) CONDUCTIVITY EQUIPMENT. 3. PLEASE REFER TO THE WRITTEN REPORT FOR METHODS, RESULTS, RECOMMENDATIONS AND LIMITATIONS DISCLAIMER 	<p>DISCLAIMER:</p>	<p>PROJECTION:</p> <p>UTM</p>	<p>DATE:</p> <p>SEPTEMBER, 2018</p>
